TWO STAGE POTASSIUM TEST TURBINE

QUARTERLY PROGRESS REPORT NO.13

For Period : May 8, 1964 Thru August 8, 1964

prepared for
NATIONAL AERONAUTICS AND SPACE ADMINISTRATION
CONTRACT NAS 5-1143

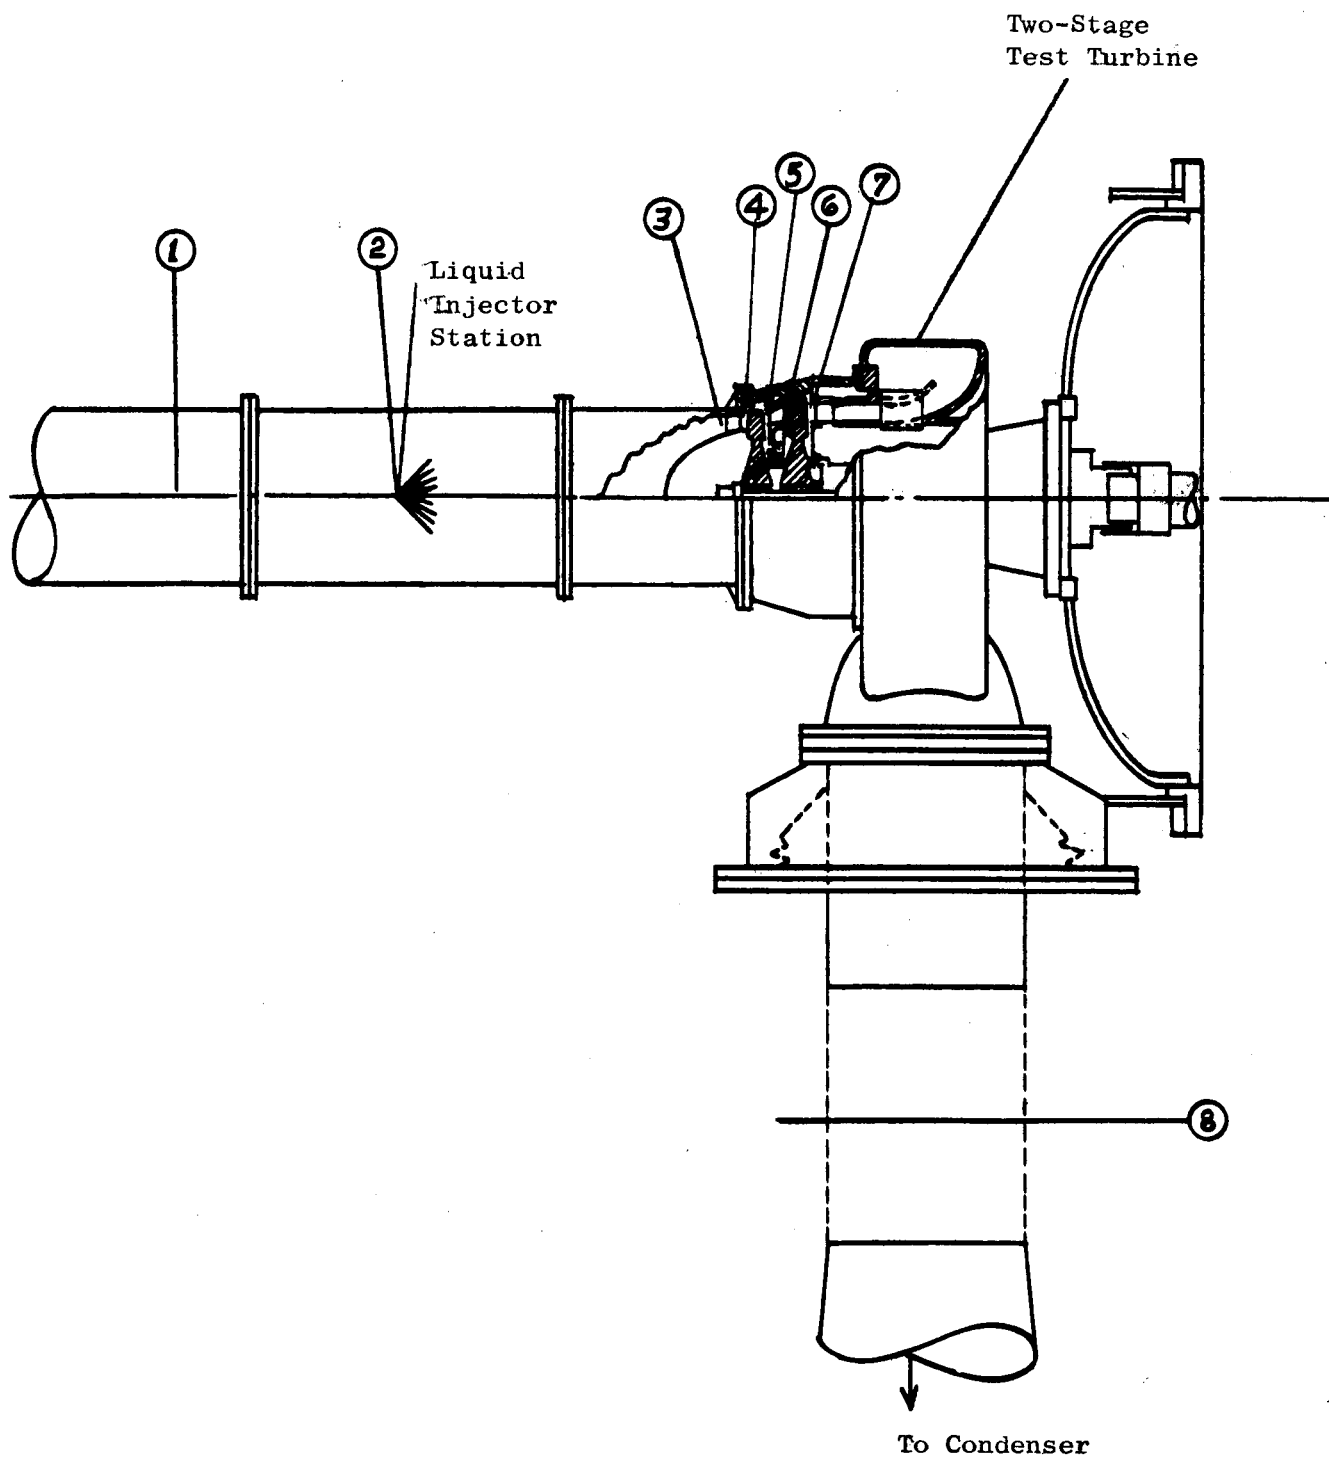
Figure 5. Instrumentation Stations

Numerals refer to instrumentation stations delineated in Figure 5.

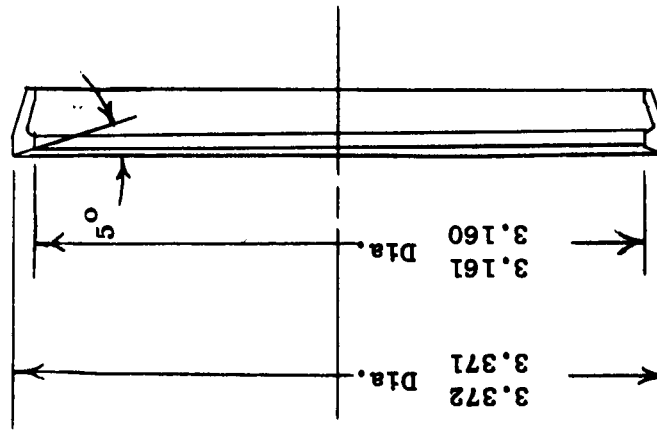
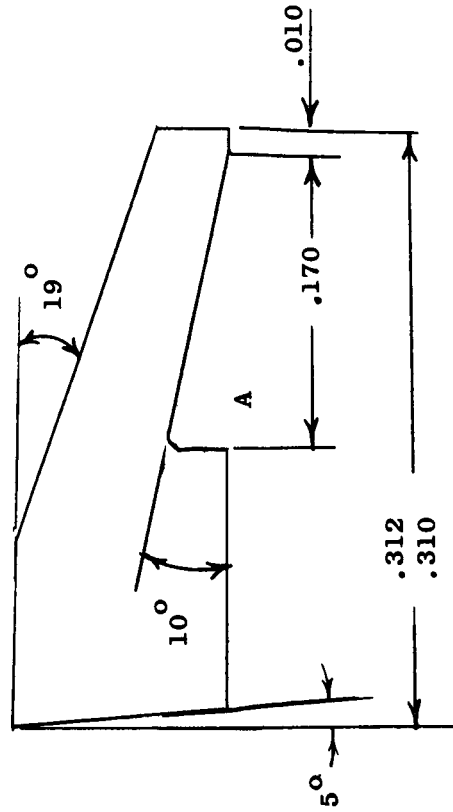
Figure 12. Nickel-Plated Stainless Steel Sealing Ring.

Test Date	Test Configuration	P ₁	P ₈	P ₃	P ₄	P ₆	P ₇	ΔP_{8-1}	ΔP_{4-6}	Test Results
	(All runs to 15,000 rpm using steam turbine as drive.)									
5-6-64	Nickel-plated metal O'Ring on shaft at end of hydrodynamic seal. (see Figure 10 and 11)	5	8	NOT MEASURED	10	10	50	3	0	Oil leakage detected along paths A & B of Figure 11. Shaft seal was inadequate. *
5-18-64	Replaced nickel plated O'Ring with nickel-plated stainless steel ring of Figure 12.	5	8		10	10	50	3	0	Oil leakage detected along paths A & B of Figure 11. Seal redesign was unsuccessful.
5-26-64	Replaced nickel-plated stainless steel ring with copper-plated 17-7 PH spring steel chevron seal of Figure 13.	5	8		10	10	50	3	0	Oil leakage still detected along paths A & B of Figure 11. Chevron sealed on ID but not on forward face.
6-5-64	Added Viton -A O'Ring to chevron seal as shown in Figure 14.	3	9		16	10	60	6	6	Oil leakage along path "A" eliminated. Still detected leakage out of cavity 2 (suspected to be along path "B"). Magnitude: 2 to 5 drops per minute.

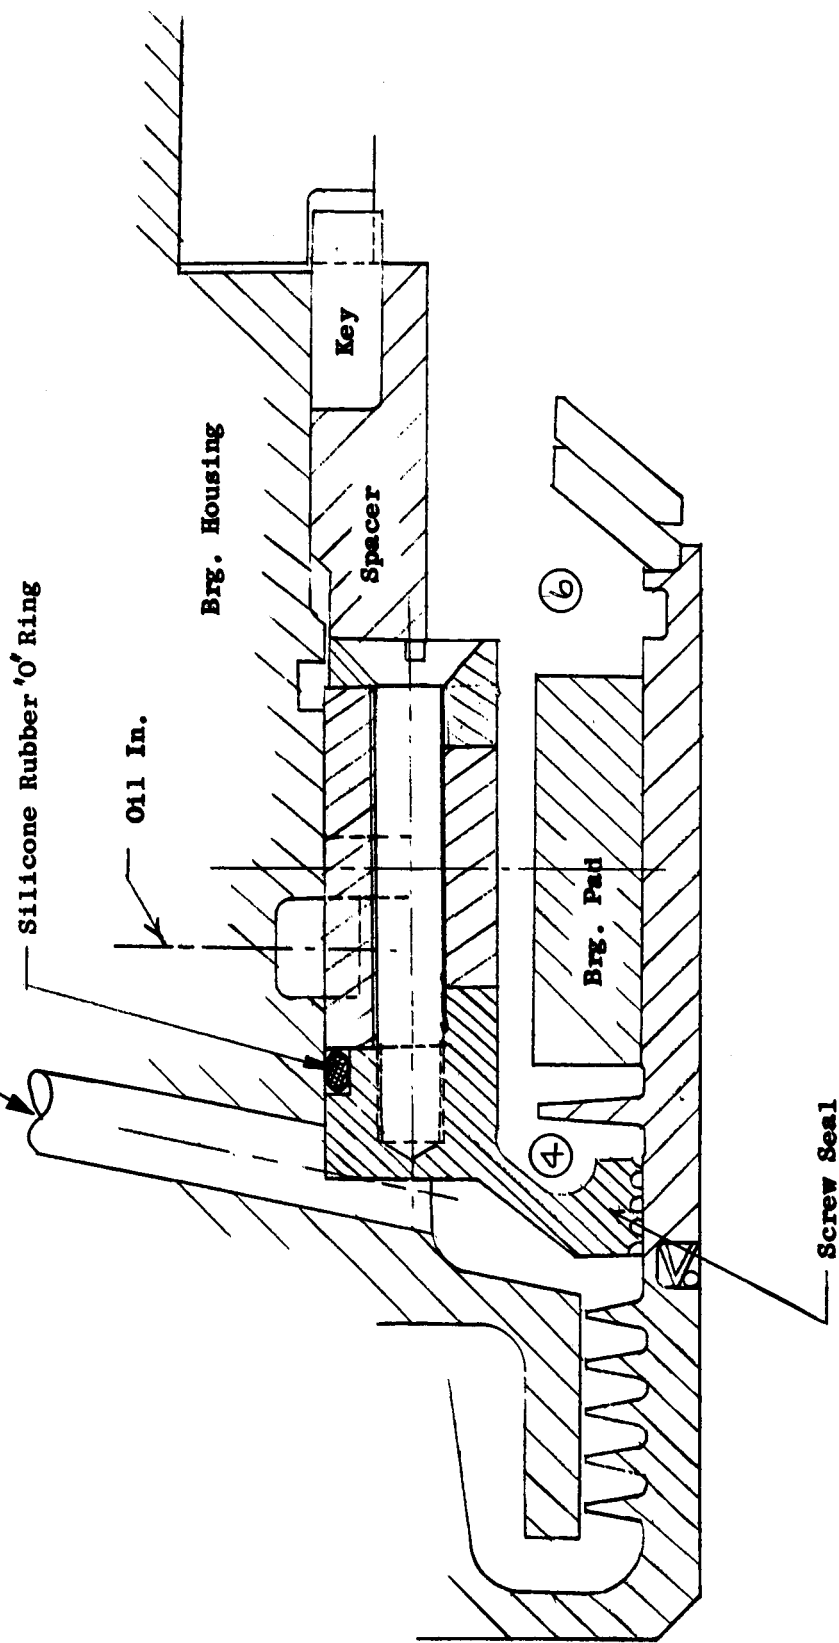
Figure 15. Screw Seal Modification of the Turbine Seal.

6-23-64	Installed bronze screw seal (Figure 15 forward of pad bearing to minimize flow of oil into cavity 4.	5	8		8	4	60	3		Test aborted when shift of sealing O'Ring on pad bearing allowed oil leakage into cavity 4.
6-29-64	Found bellows hose out of cavity 2 to be oil-laden and replaced with smooth wall-tube, repeated above speed test with pressure drops across seals.	3	3.6		8	4	58	0.6	4	No indication of oil leakage anywhere. Apparent leakage of oil along path "B" was due to exhausting of residual oil out of outlet line which had been oil-laden during earlier mishap. (Possibly 4-13-64). Even oil injected directly into cavity 4 did not migrate upstream through labyrinth seals.

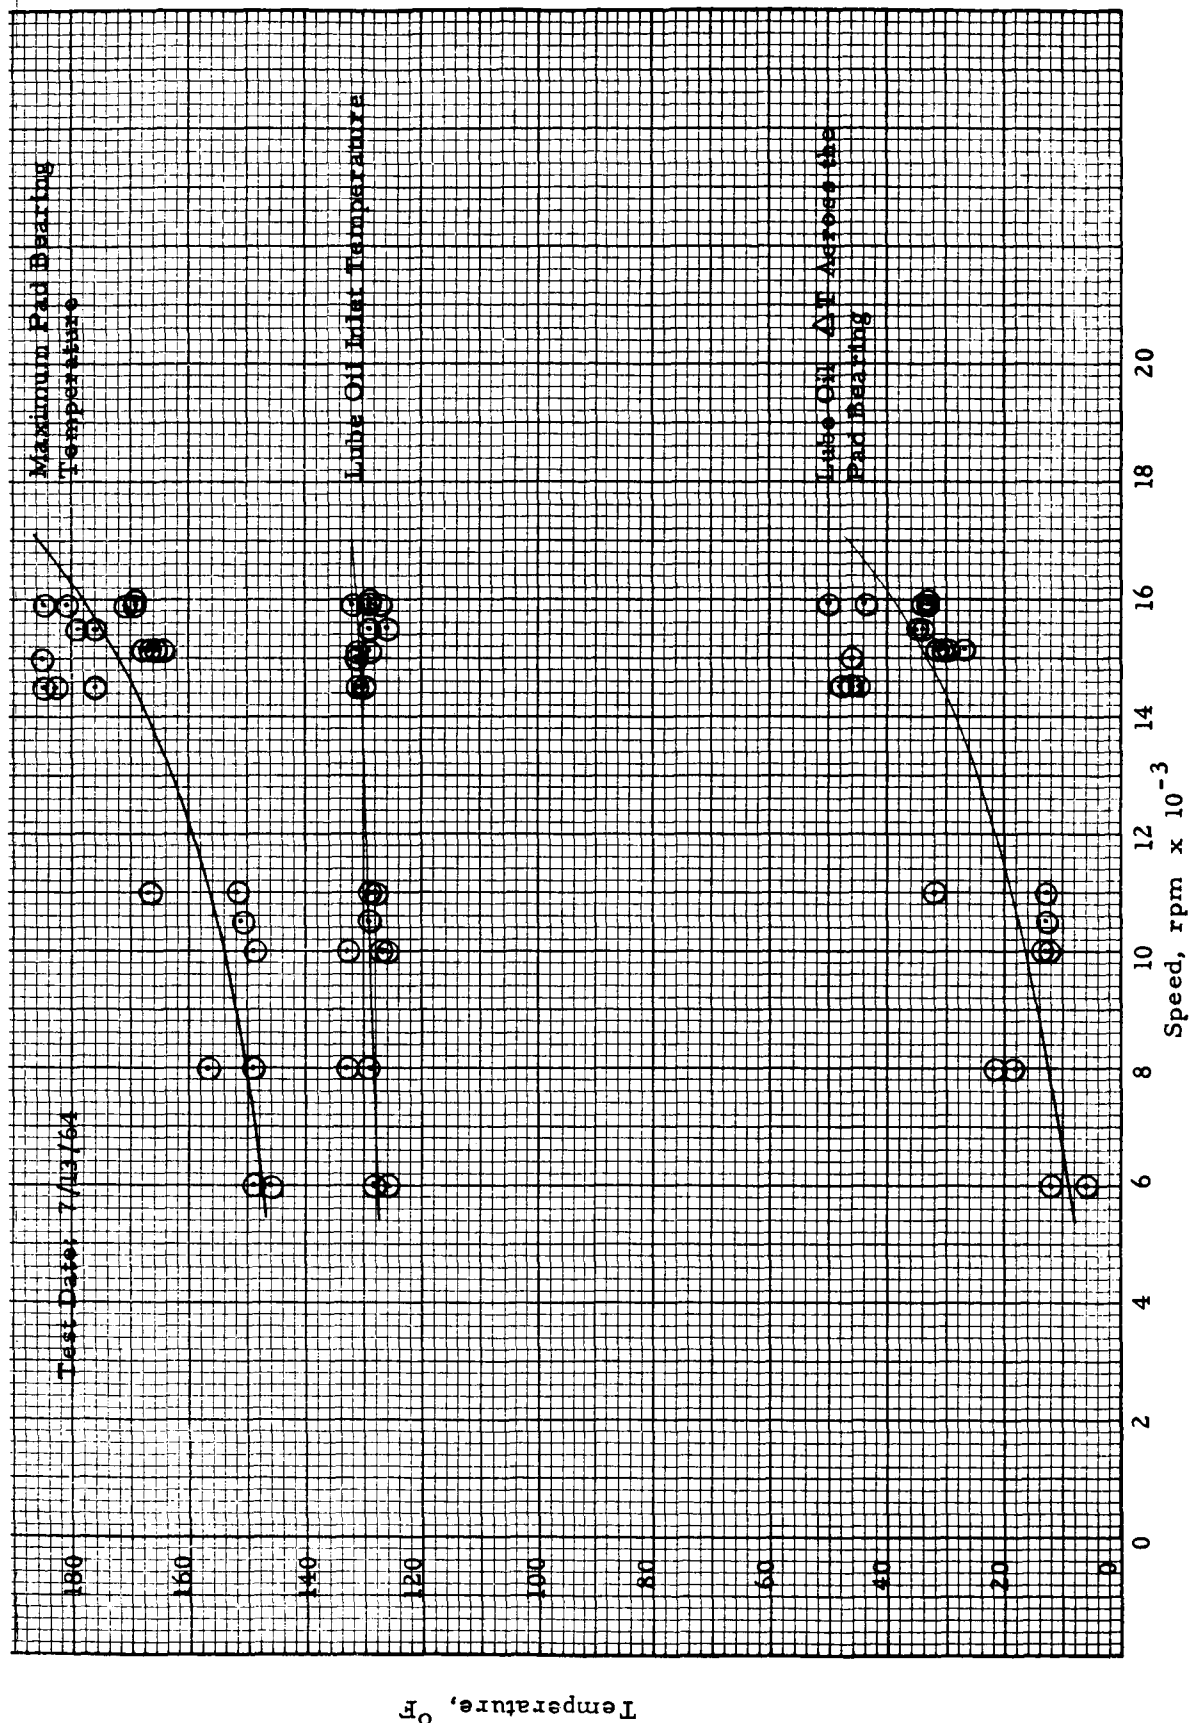
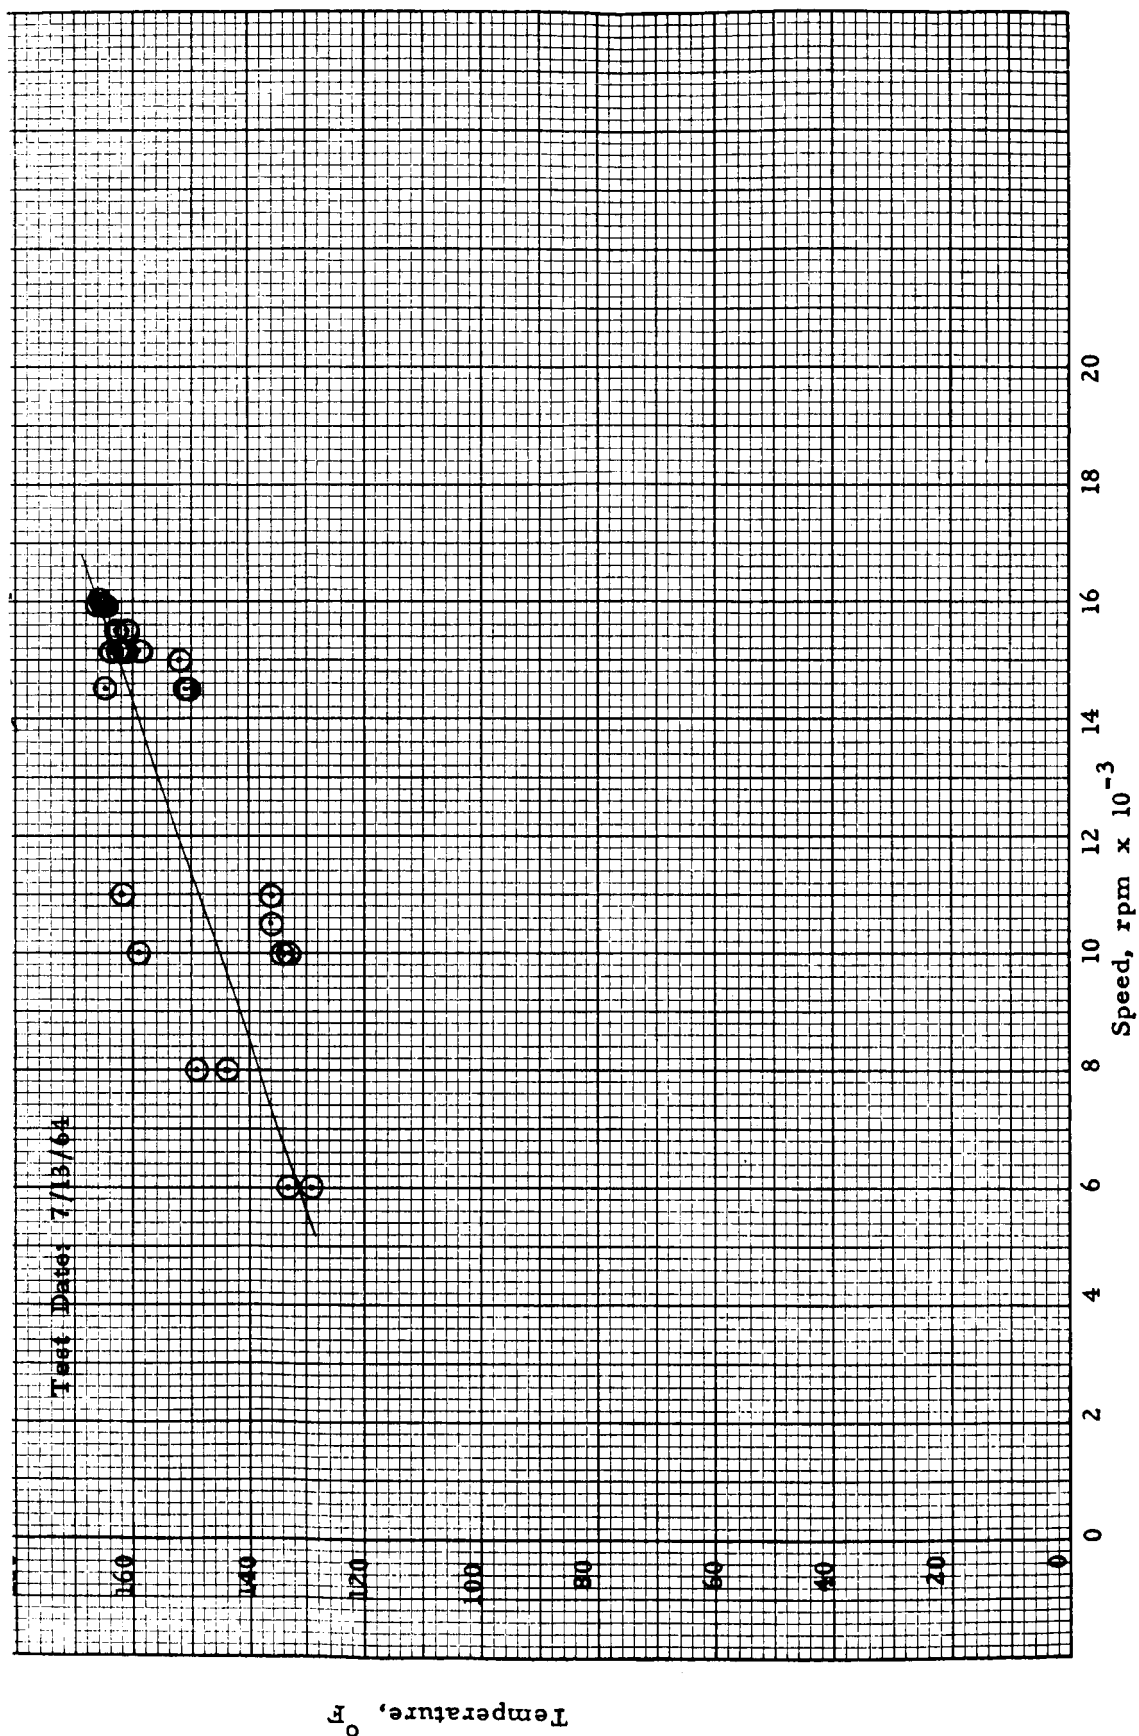
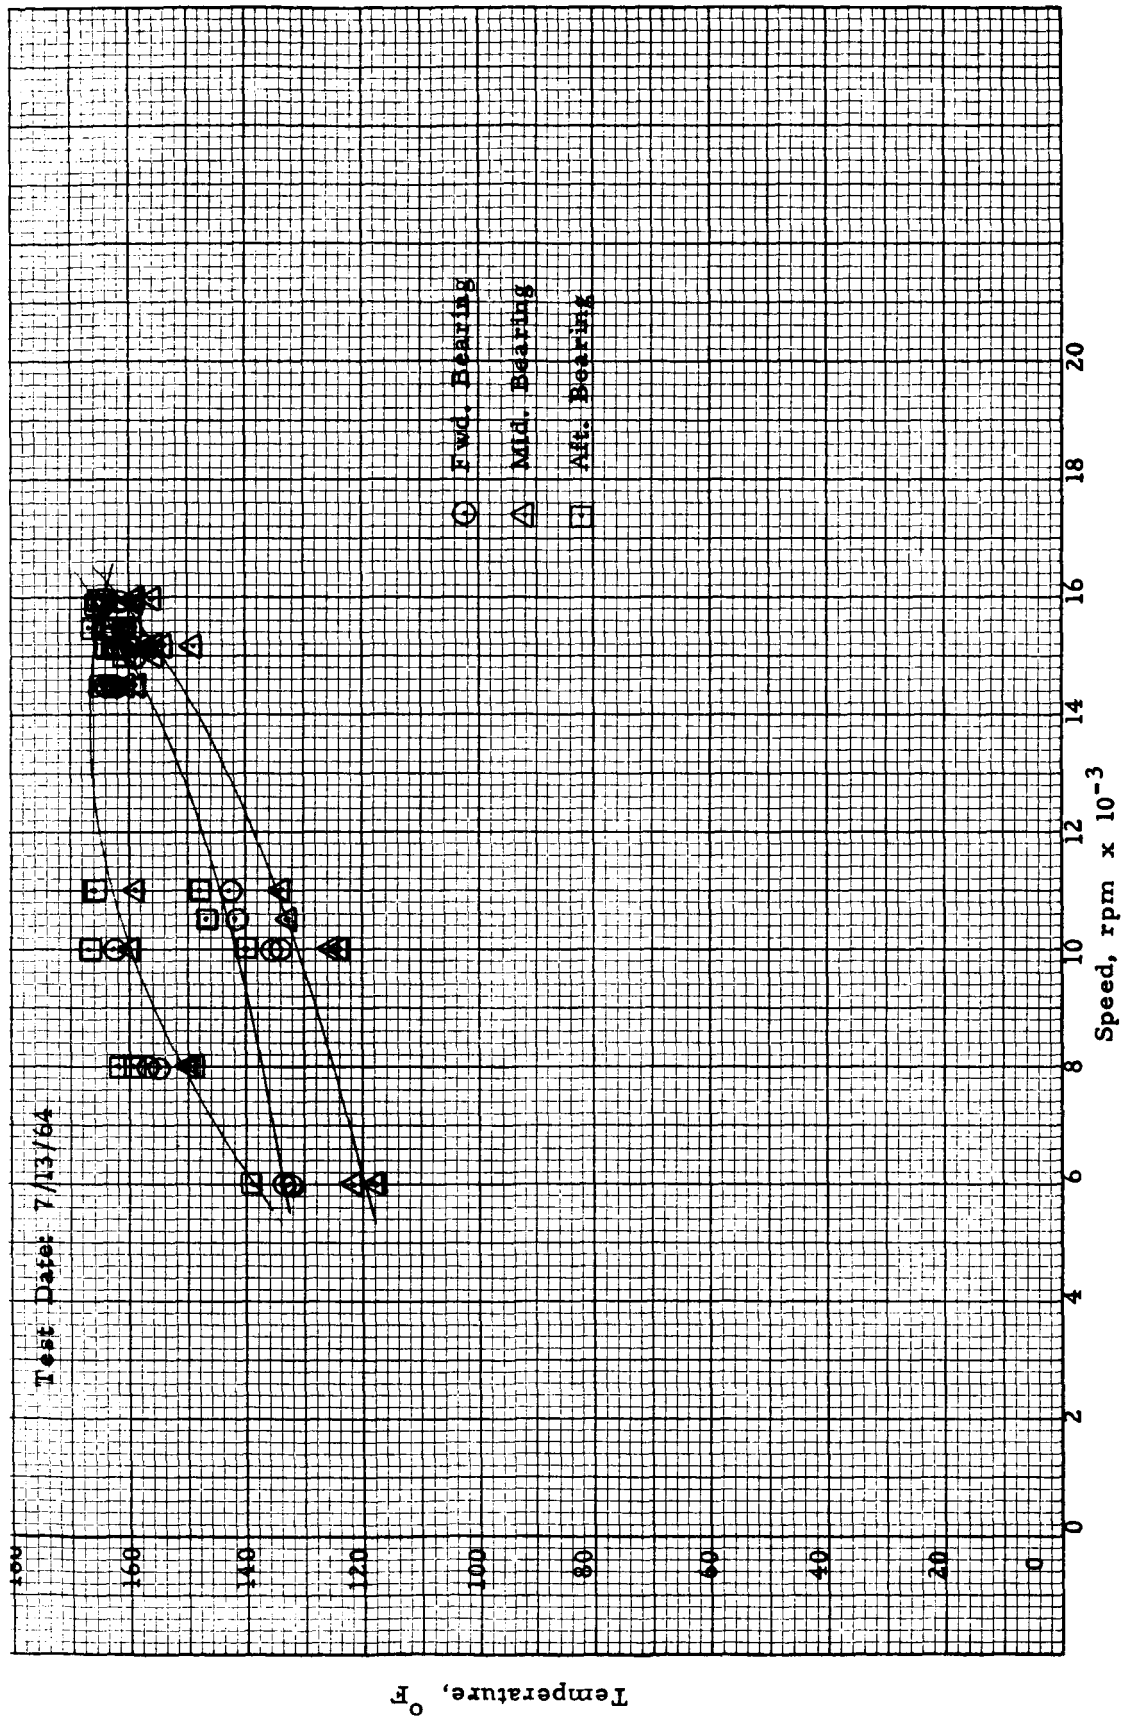
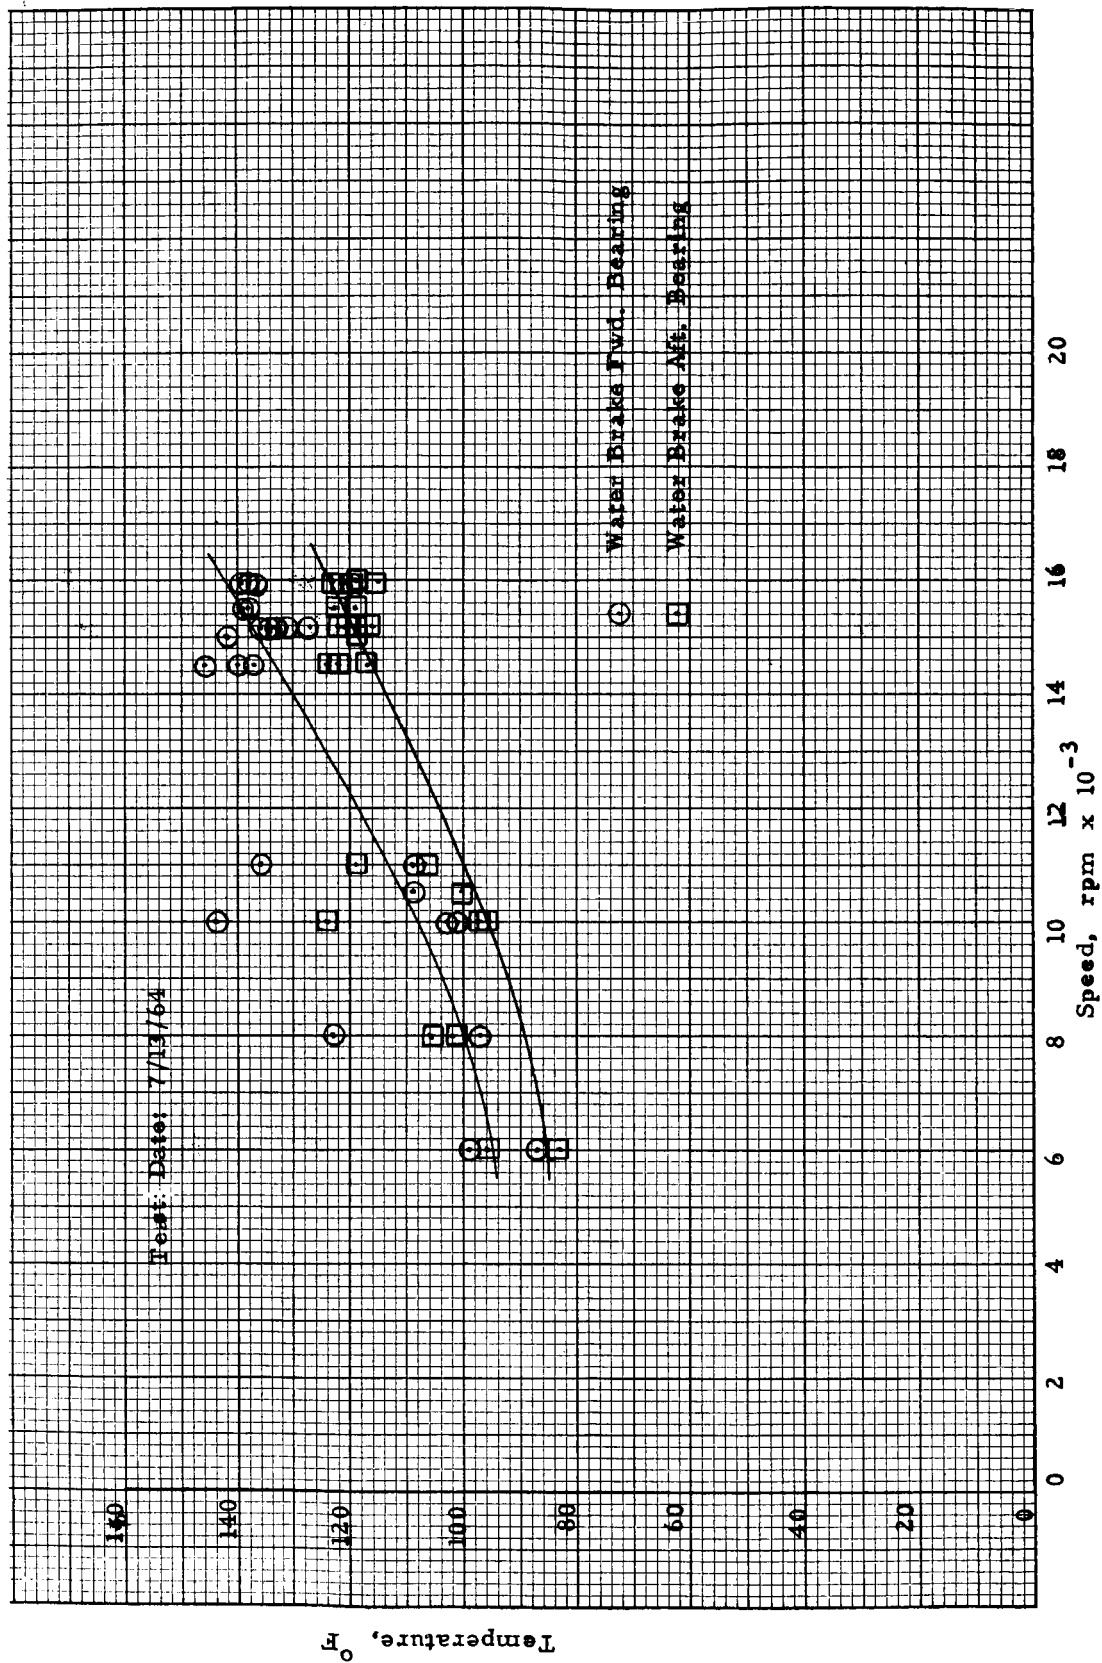
Figures 21 through 24 show the various temperatures of the turbine and loading equipment bearings during the testing of 7-13-64. These plots show the results of data taken over the entire run, from start-up to shutdown, and for this reason the data show some scatter. Superposed on the graphs are the predicted values from the test plan (obtained during steam pretesting).

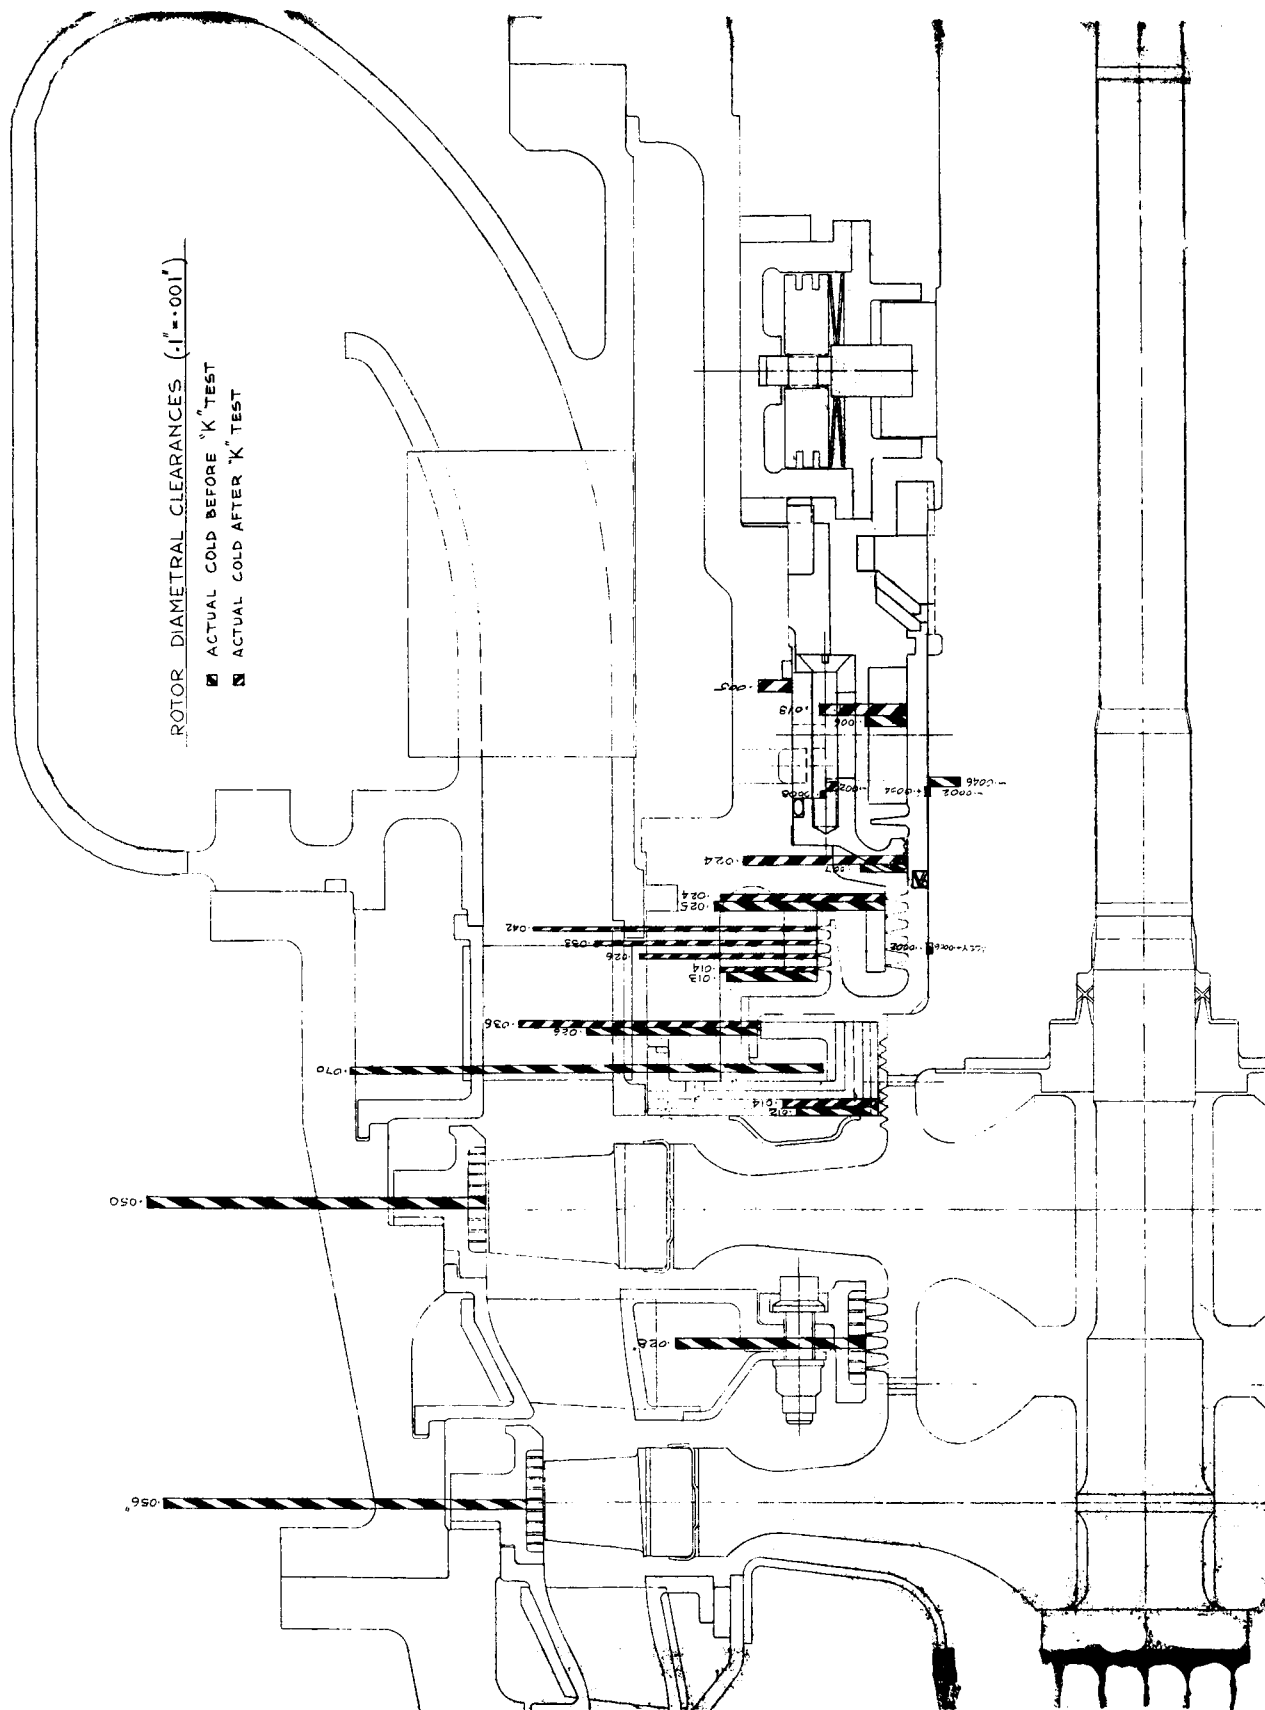
Figure 31. Rotor Diametral Clearance

and the extraction of the bearing housing. Figure 29 shows a view into the rear of the turbine with the housing removed. The aft face of the rear turbine wheel and the protruding shaft can be seen. The bearing housing is shown in Figure 30 immediately after its removal. The oxidized residual potassium can be seen on its surface. The hydrodynamic seal was removed along with the housing by sliding it off the turbine shaft. The forward bolts holding the hydrodynamic seal to the bearing housing were loose, allowing a definite leakage of potassium out through the joint between these two parts. Inspection of the parts showed that no mixing of oil and potassium had occurred during the previous vapor testing despite the drastic speed fluctuations. However, several seal surfaces had rubbed. The parts were disassembled and inspected. Figure 31 shows the inspection clearances both before and after the potassium tests. Although all screw seals and labyrinth seals had experienced rubbing, no indications of blade tip rubs were observed, by a visual inspection made on the aft face and outer tip seal surface of the second stage wheel with a boroscope. Also, no indications of axial rubs were observed throughout the turbine. Although bending of the stiff shaft was insignificant, it appeared that a radial motion of the shaft had allowed seal surfaces to come into initial contact and begin to rub. The conclusion drawn from inspection data is that due to excessive

The pivoted pad bearing is being remachined for a better fit of the pads into the outer retaining ring. Close control of bearing tolerance is being maintained to get exactly the required clearances. A selective fit of the bearing into the bearing housing, and a subsequent radial key arrangement is being installed to prevent any radial motion which might occur during differential thermal expansion of the bearing and housing. The bearing feed system is being improved to eliminate the need for the silicone rubber O-ring which was previously installed as shown in Figure 15. This involved individual feeding of each bearing pad, which will also allow observing of the flow to each pad if necessary.

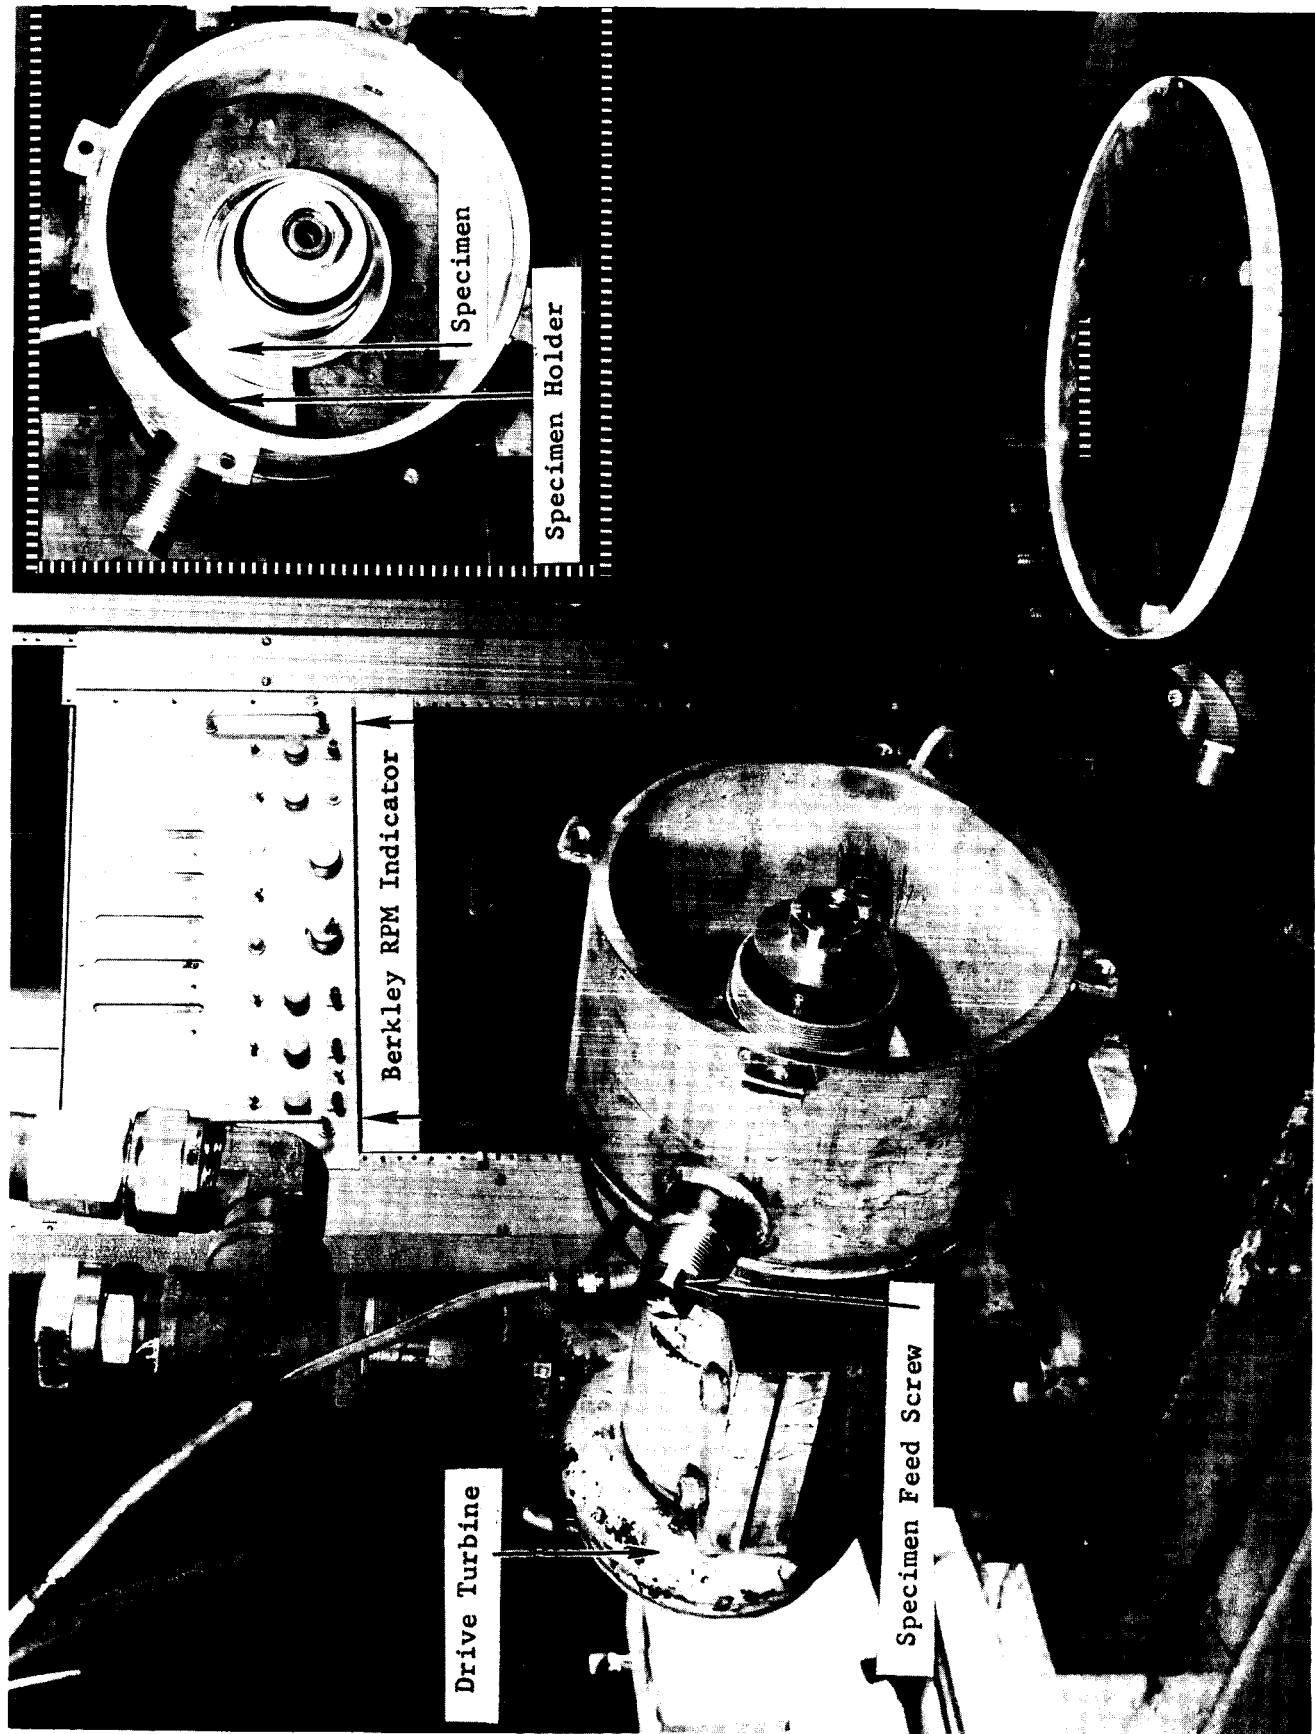
Figure B-1. Turbine Rub Test Facility (C64032524)
Insert (64032523).

The purpose of the tests was satisfied because better labyrinth seal materials could be recommended which would result in lower friction and less galling along with equal potassium corrosion resistance.

Seal Materials - Recommendations were made for modified materials to be used in the turbine rub seals. Bases of the recommendations were (1) experience in the turbine test, (2) materials rub tests at Evendale described in Appendix B attached, and (3) experience at SAED, Lynn, Massachusetts and Steam Turbine M & P Lab, Schenectady. Electroplated copper will be used in the argon buffer seal labyrinths against bare A-286 teeth, (Refer to Figure 11) with silver as an alternate in the non-potassium seal. The bearing oil screw seal will use a silver alloy although copper or various bronze or brass materials might also be used. (Refer to Figure 15) A leaded nickel-tin bronze and free machining brass are being considered for additional rub tests to certify their usefulness in the oil screw seal. Procurement of these materials has been initiated.

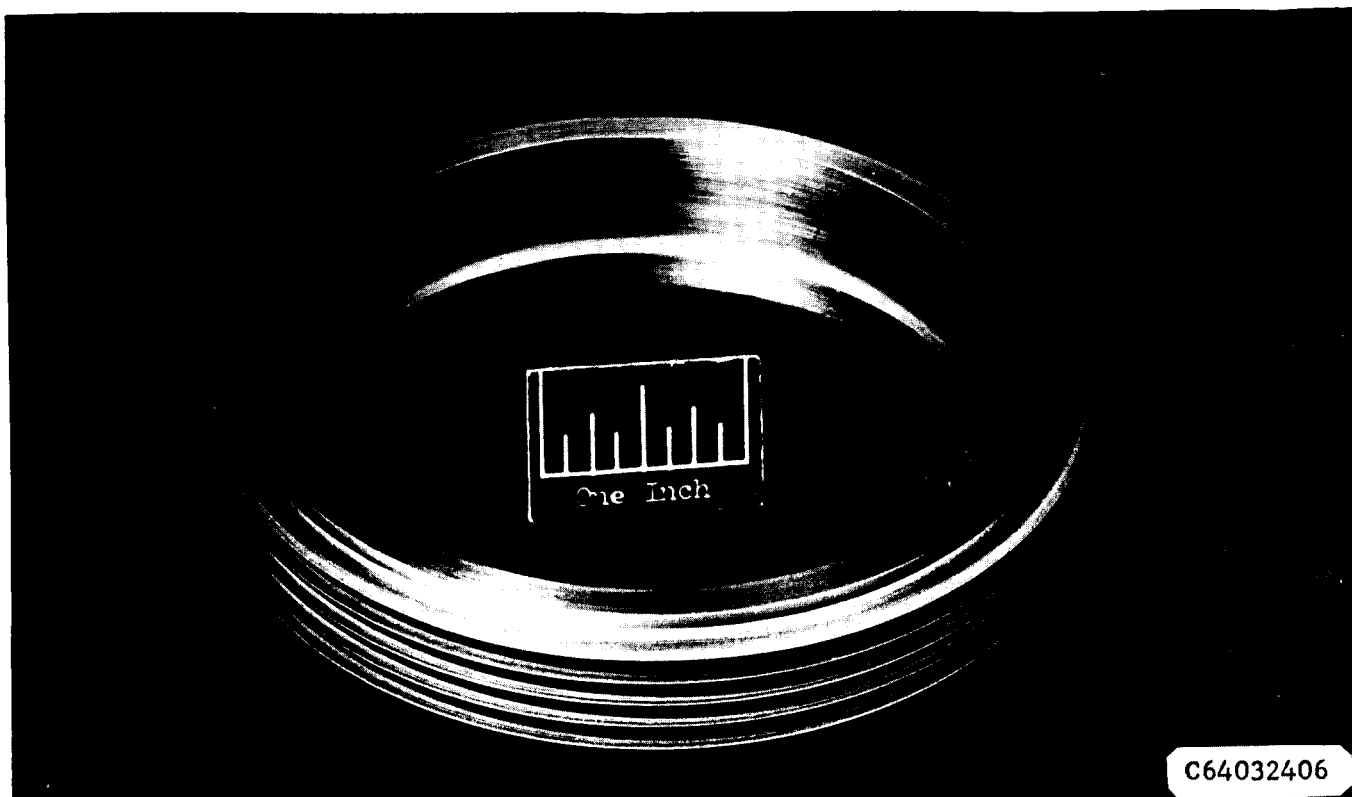
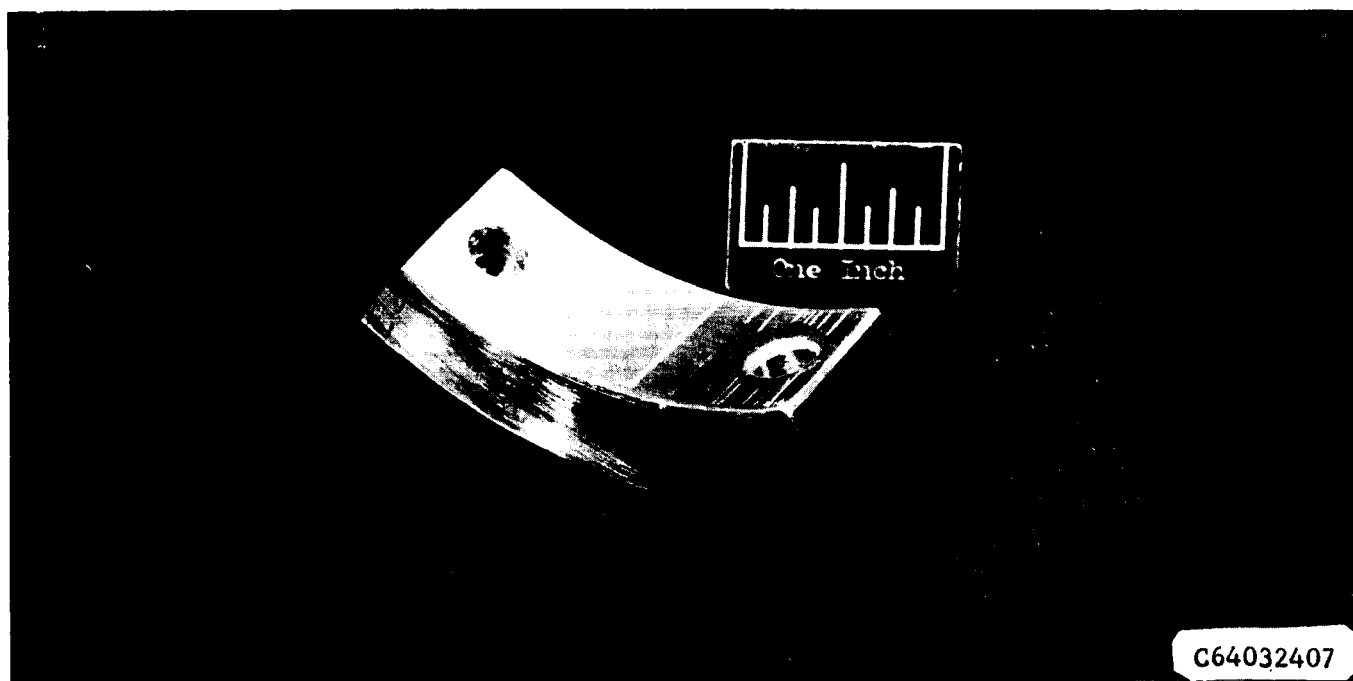
Figure B-2. Test Components, Top, Labryinth Teeth Ring (C64032406)
Bottom, Silver Electroplated Rub Specimen (C64032407)

1A. Silver Plated Specimen versus Micro-Crack Chromium Plate -
